Laboratory Management

Ultracentrifuge explosion damages laboratory

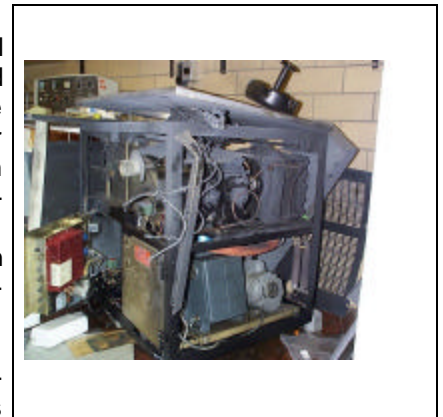
On December 16, 1998, milk samples were running in a Beckman L2-65B ultracentrifuge using a large aluminum rotor (a rotor is a large metal object that holds the individual sample tubes and is connected to the spin drive of the centrifuge). The rotor had been used for this procedure many times before. Approximately one hour into the operation, the rotor failed due to excessive mechanical stress caused by the "G" forces of the high rotation speed. The subsequent explosion completely destroyed the centrifuge. The safety shielding in the unit did not contain all the metal fragments. The half-inch thick sliding steel door on top of the unit buckled allowing fragments, including the steel rotor top, to escape. Fragments ruined a nearby refrigerator and an ultra-cold freezer in addition to making holes in the walls and ceiling. The unit itself was propelled sideways and damaged cabinets and shelving that contained over a hundred containers of chemicals. Fortunately, sliding cabinet doors prevented the containers from falling to the floor and breaking. A shock wave from the accident shattered all four windows in the room. The shock wave also destroyed the control system for an incubator and shook an interior wall causing shelving on the wall to collapse. Fortunately the room was not occupied at the time and there were no personal injuries.

Remains from centrifuge explosion.

Rotors on high-speed centrifuge and ultracentrifuge units are subject to powerful mechanical stress that can result in rotor failure. In addition, improper loading and balancing of rotors can cause the rotors to break loose while spinning. Everyone using this type of equipment needs to know the proper operating procedures for the specific unit being operated, including how to select, load, balance and clean the rotor. These procedures are explained in the unit's operating manual. It is essential that you have the owner's manual for your unit and that you follow the manufacturer's instructions carefully. Some general considerations are covered in the "Beckman Coulter Rotor Safety Guide" available for download in Adobe Acrobat PDF format. (<ftp://ehs.ucdavis.edu/docs/cntrfuge/rotorsafetyguide.pdf>)

It is also necessary to "de-rate" some rotors (limiting the maximum speed at which the rotor is used to some level below the maximum speed listed for the rotor when new) based on the amount of use the rotor has received. This requires that operators maintain a comprehensive use log for each rotor. These procedures are explained in the operating manual.

In the event of operating problems with high-speed centrifuge or ultracentrifuge units, or signs of wear or damage to rotors, the equipment should be taken out of service immediately and clearly marked "**Warning -DO NOT USE**" until checked by an authorized service representative.

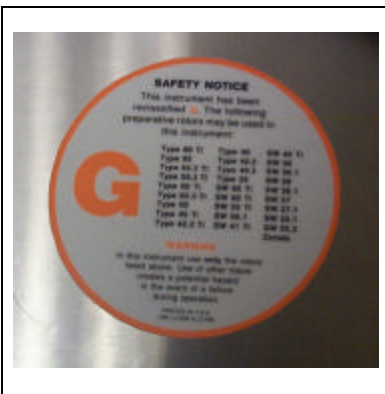
Decal for older units specifying approved rotor models

Older equipment does not have all the safety features built into new units. They are more likely to experience rotor failures and they are more likely to cause injuries when they fail. It is critical that all safety and maintenance procedures specified by the manufacturer are followed. Based on the investigation of the December 16, 1998 accident, EH&S learned that Beckman L2 and L3 series ultracentrifuges have special operating procedures and restrictions to reduce the risk of damage and injuries. This includes an orange decal on the sliding door that specifies the rotor models that are safe to use in a particular unit.
